Technical Inspection Report  
Bureau of Ordnance Group

OPERATION CROSSROADS.

TESTS 'A' AND 'B'.  
VOLUME III.  
PART I.  
Photographic  
Appendix [u]. 8

Subject: Bureau of Ordnance Material Group Final Report for Tests "A" & "B".

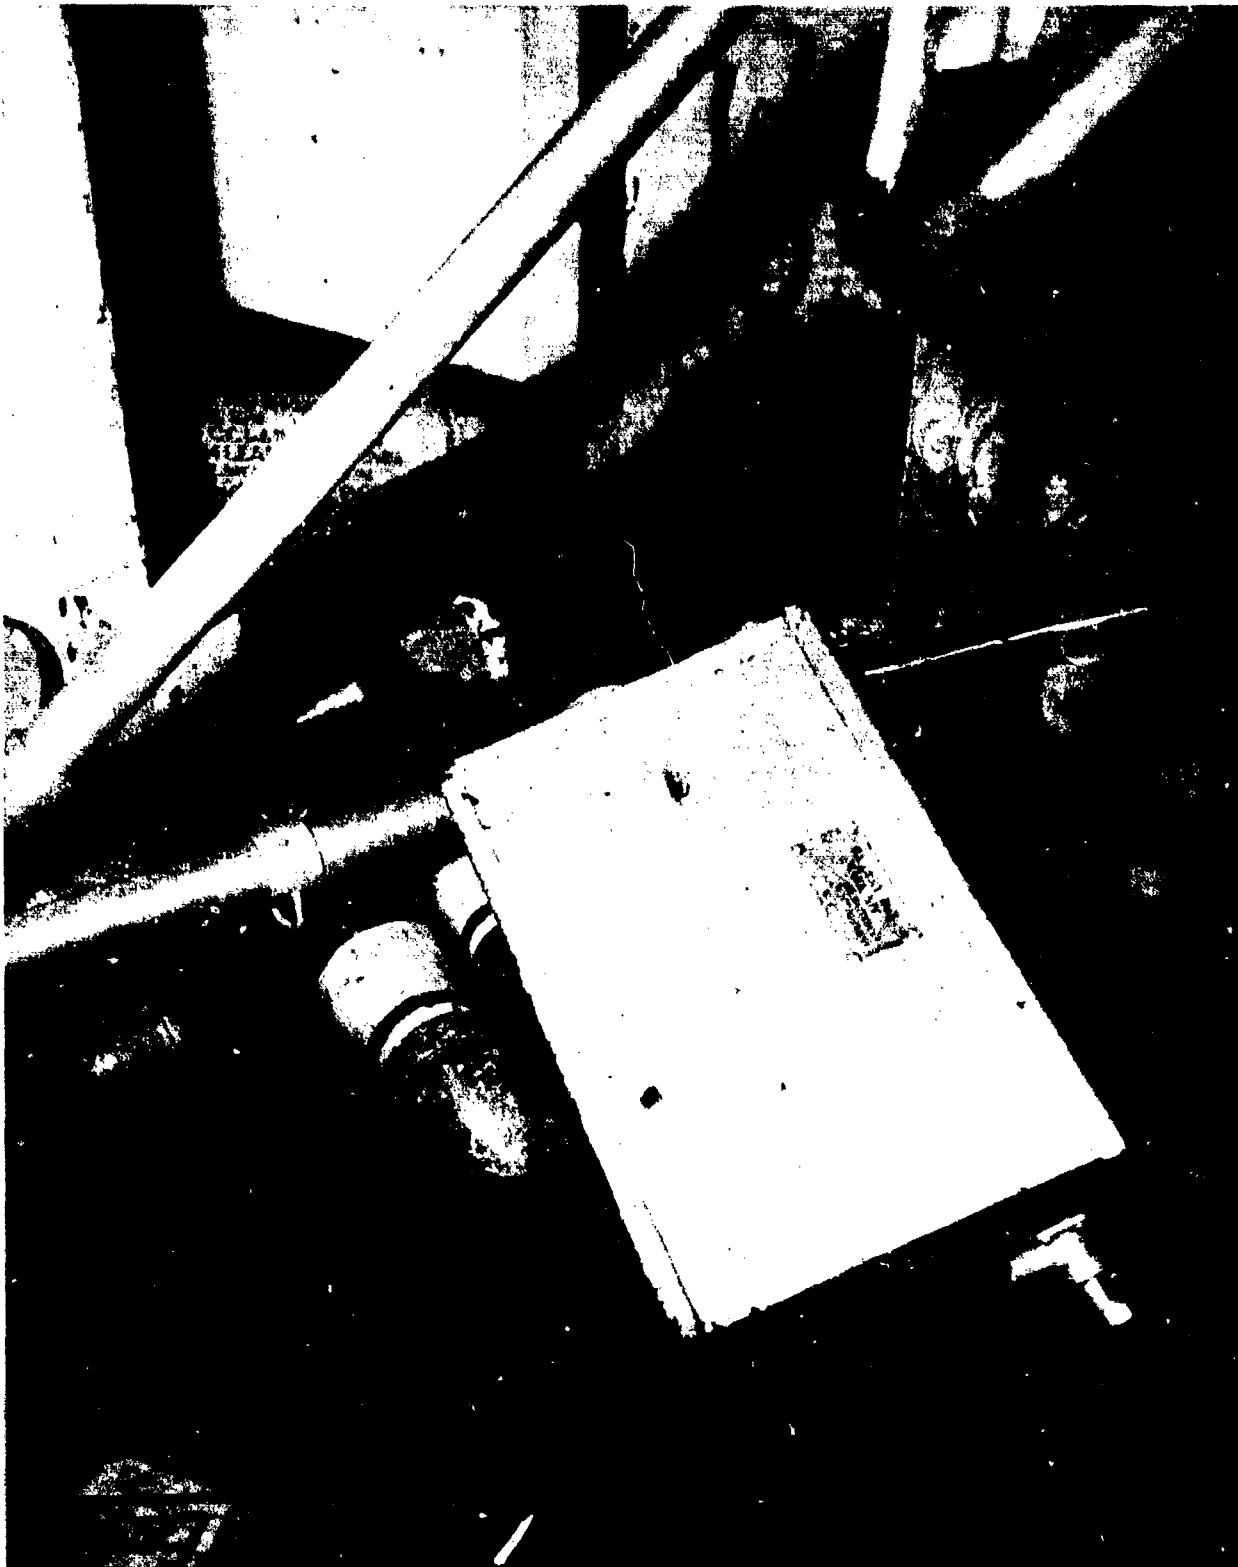
U.S.S. HUGHES (DD-410) - After Baker  
Shows the effect of shock on the 5"/38 Upper Handling  
Room. Slight dents were detected in a few rotating bands  
on the projectiles.  
Photo. No. AB-CR-76-1931-1.

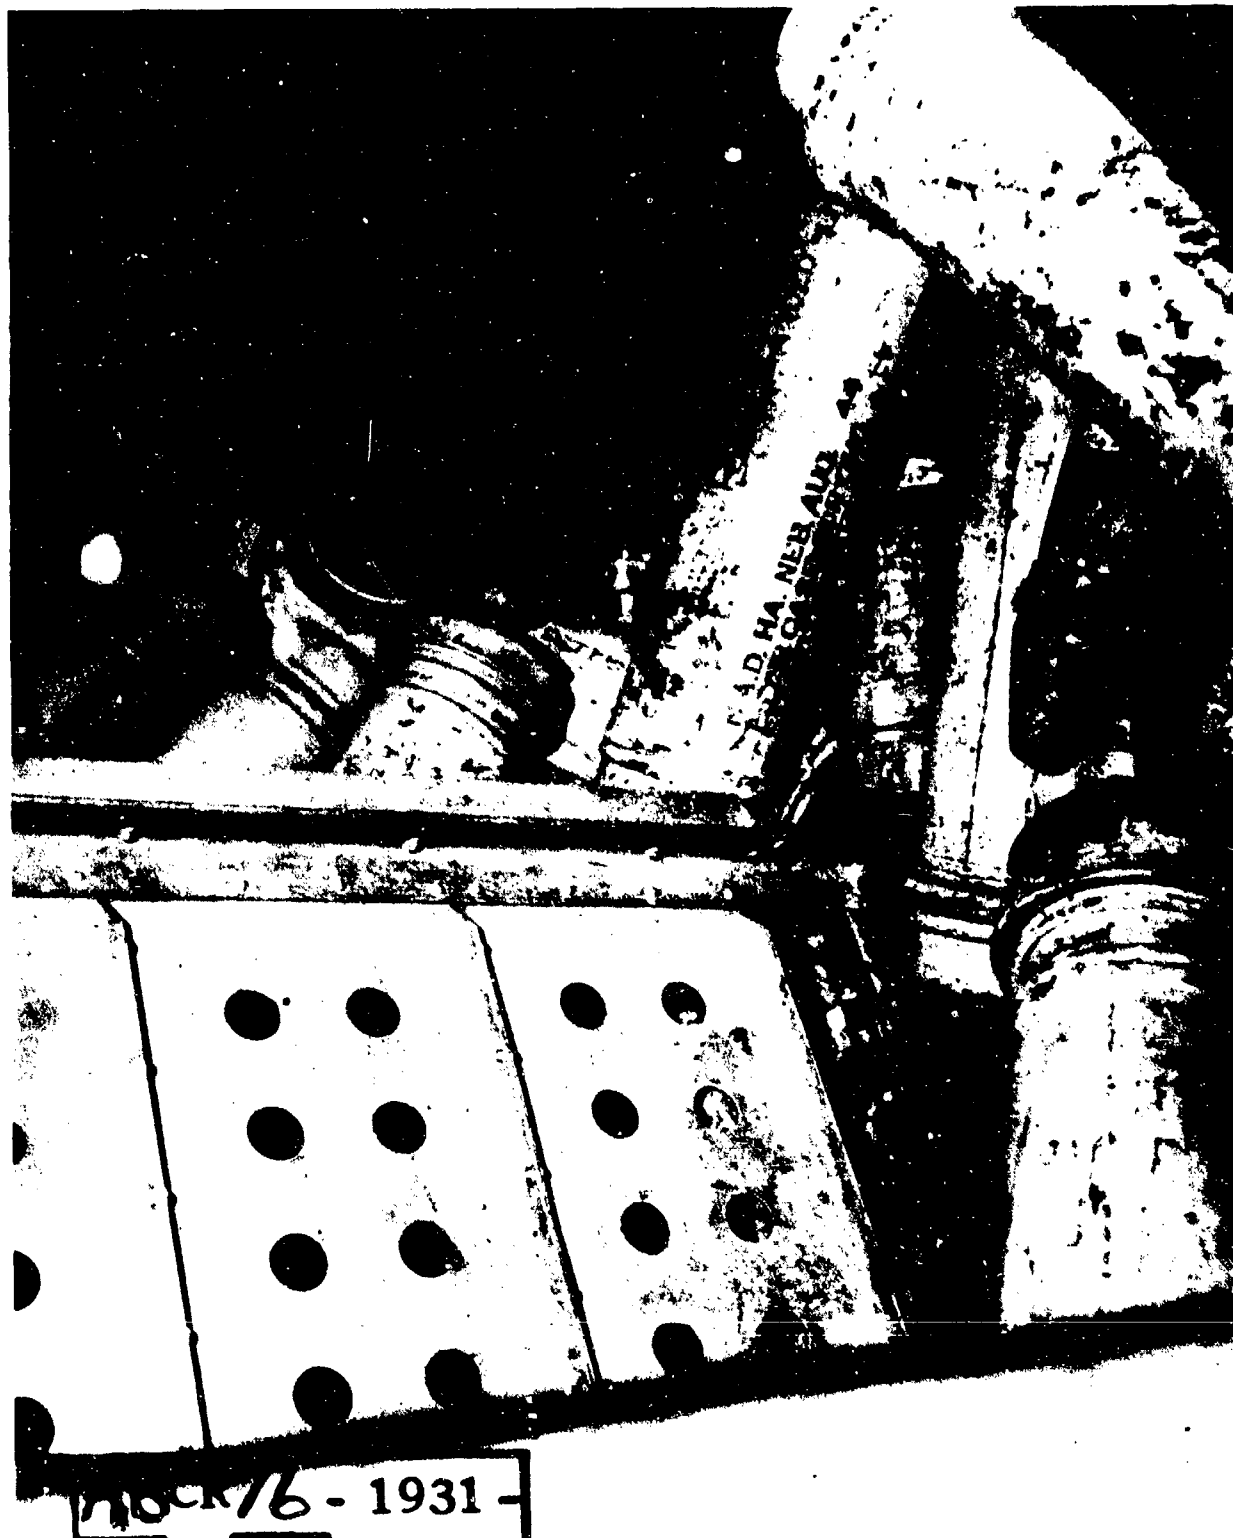
U.S.S. HUGHES (DD-410) - After Baker  
Shows the effect of shock on the 5"/38 Powder  
Stowage in the Upper Handling Room. Dents were  
inflicted in some of the Cartridge Cases ranging  
from slight to severe. The failure of battens and  
stanchions was marked.  
Photo. No. AB-CR-76-1931-2.

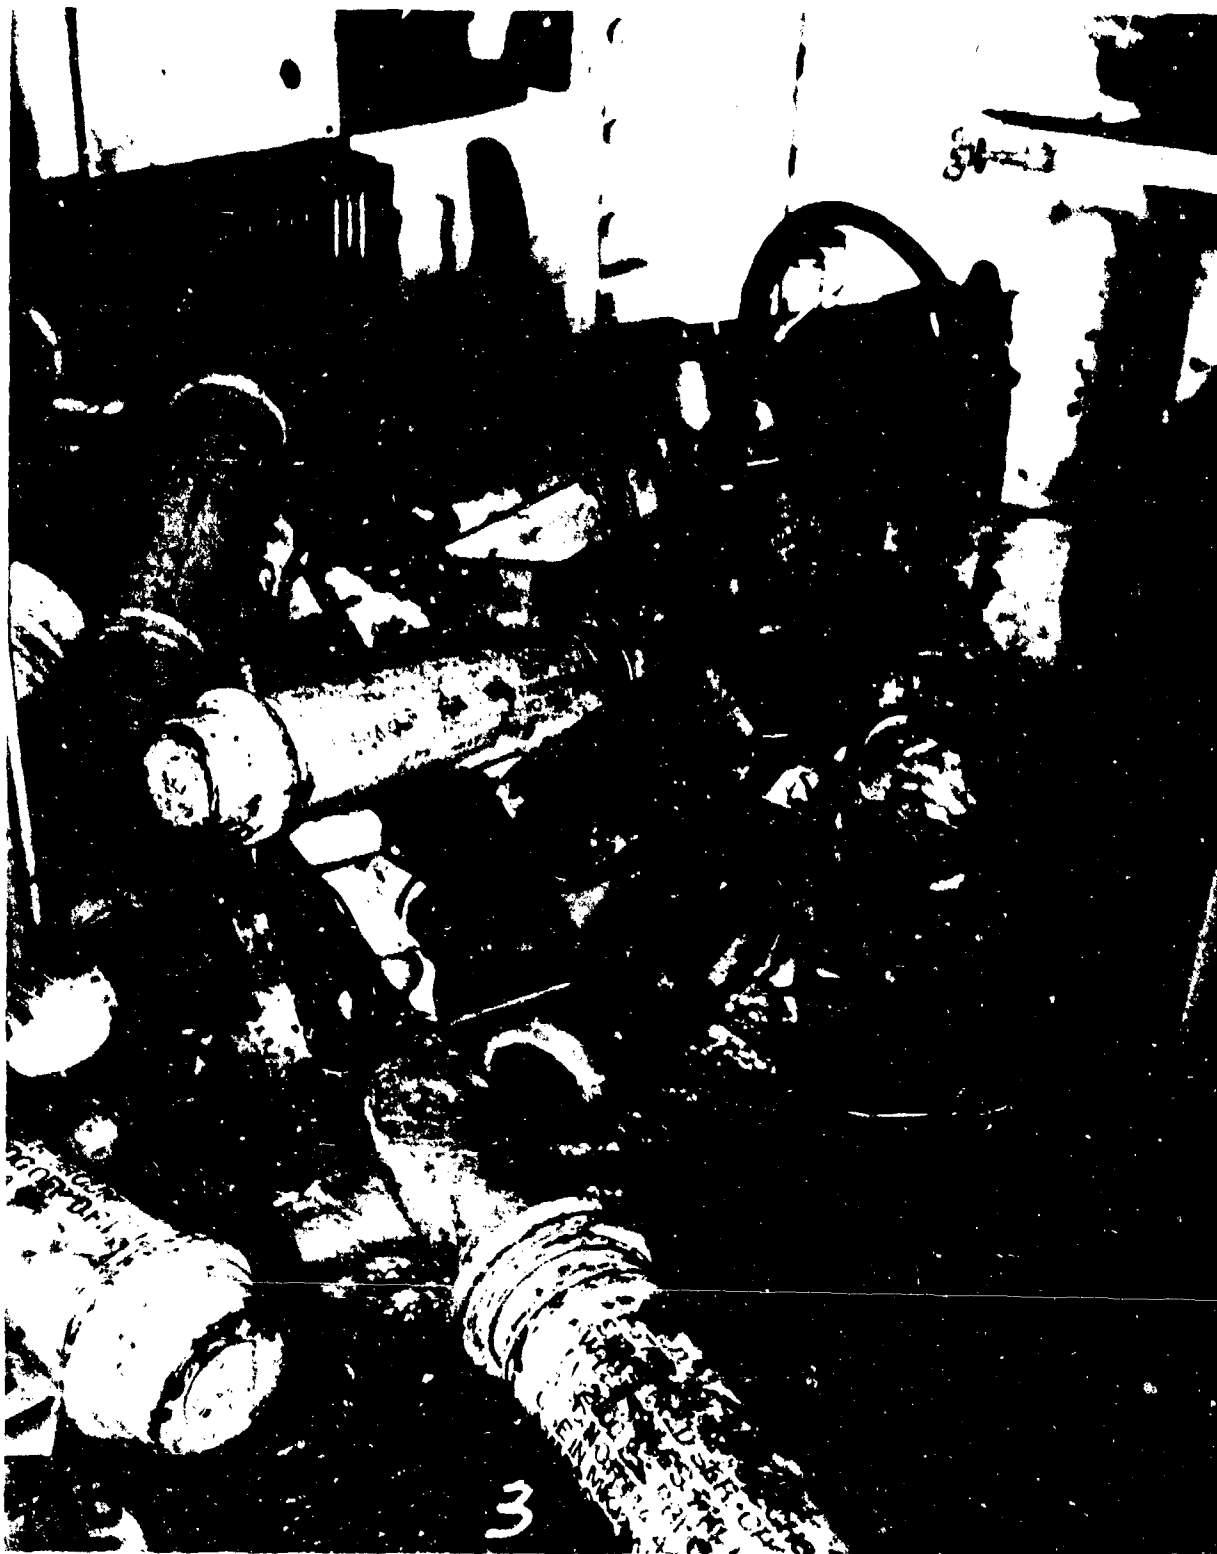
U.S.S. HUGHES (LD-410) - After Baker  
Shows the effect of shock on the 5"/38 Powder and Projectile Storage in the  
Upper Handling Room. Few projectiles rotating bands and cartridge cases were  
dented ranging from slight to severe. The failure of battens and stanchions was  
marked.  
Photo. No. AB-GH-76-1931-3.

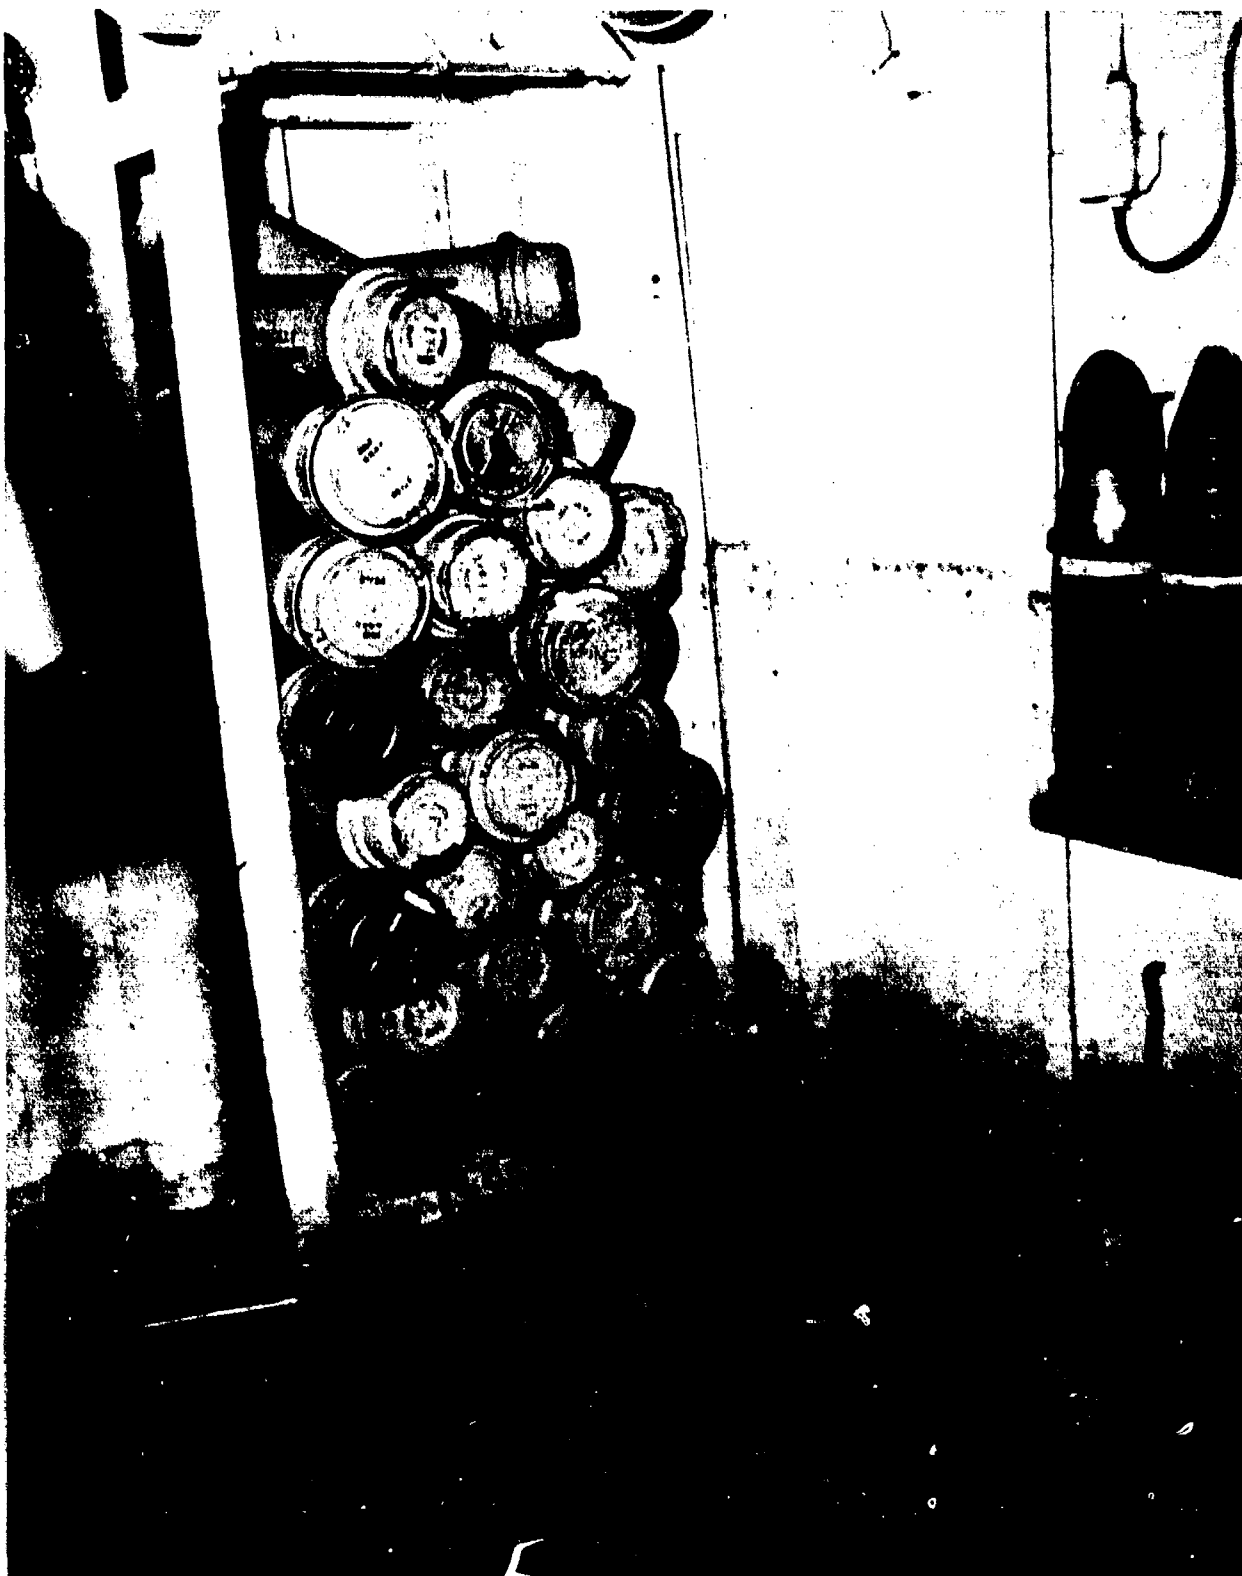
U.S.S. HUGHES (DD-410) - After Baker  
Shows the Upper Handling Room of No. 4, 5"/38 Gun  
Mount and the extent of displaced ammunition caused  
from shock. The failure of battens was marked.  
Photo. No. AB-Ck-76-1931-5.

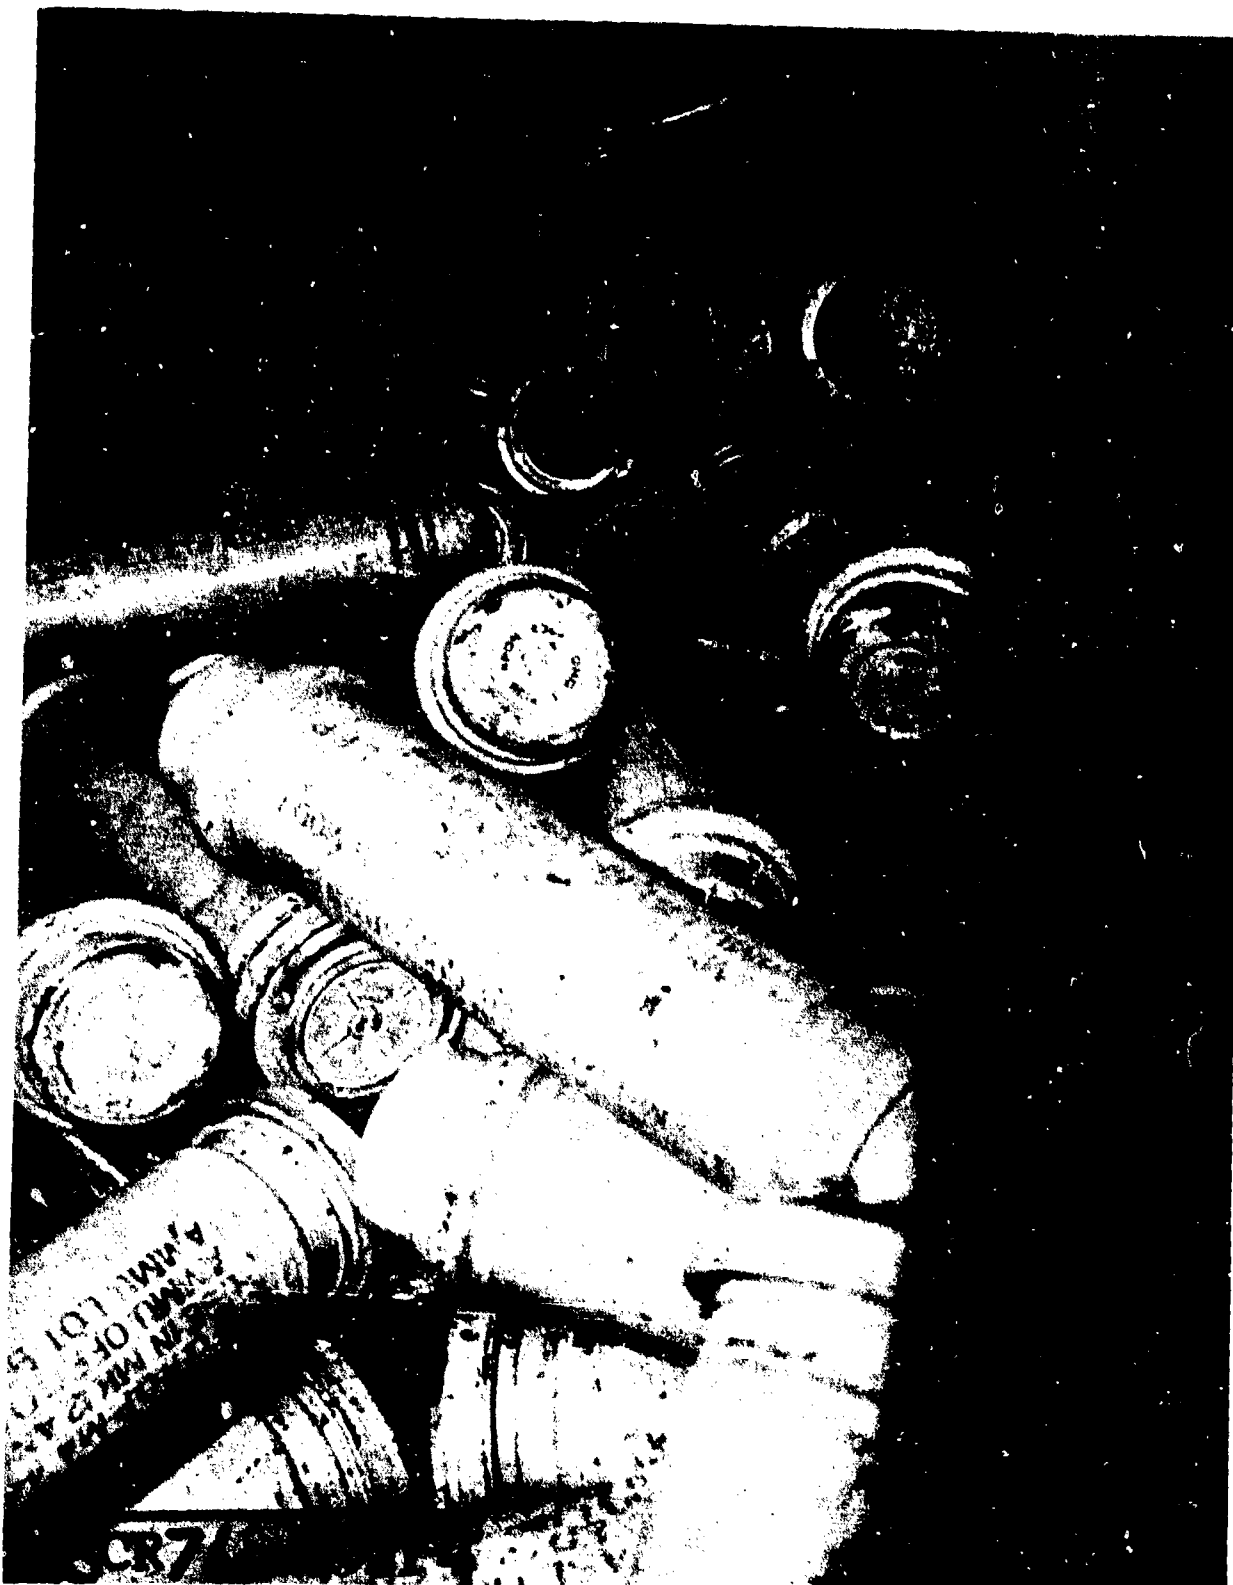
U.S.S. HUGHES (ED-410) - After Baker  
Shows the effect of shock on the 5"/38 Powder Stowage  
in Magazine, C-404-M. The failure of battens and stanchions  
was marked. Few Powder Tanks and Cases were dented.  
Photo. No. AB-Ch-76-1931-7.

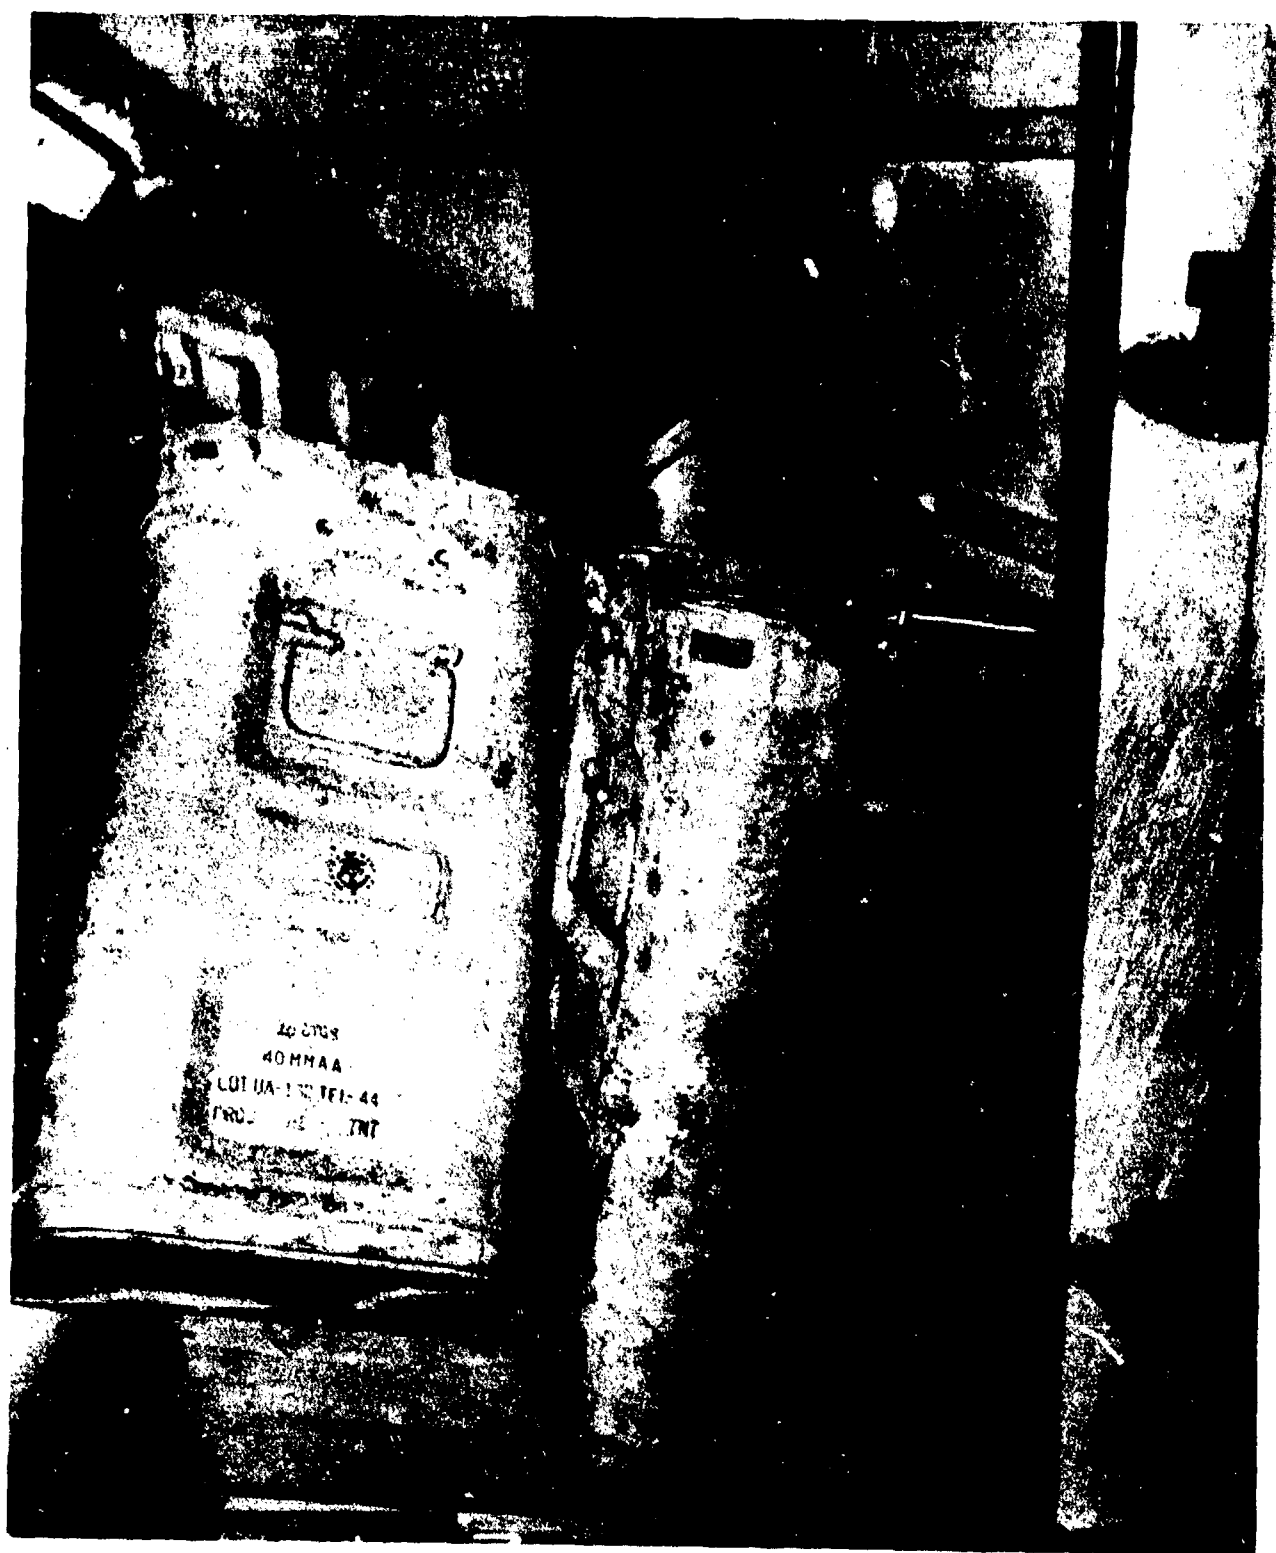
U.S.S. HUGHES (DD-410) - After Baker  
Shows the effect of shock on the 40 MM Ammunition Storage in the 40 MM  
Clipping Room on the Main Deck, Frame 135. The failure of battens and  
stanchions was marked. Ammunition as seen in this photo remained unharmed.  
Photo. No. AB-CR-76-1932-3.

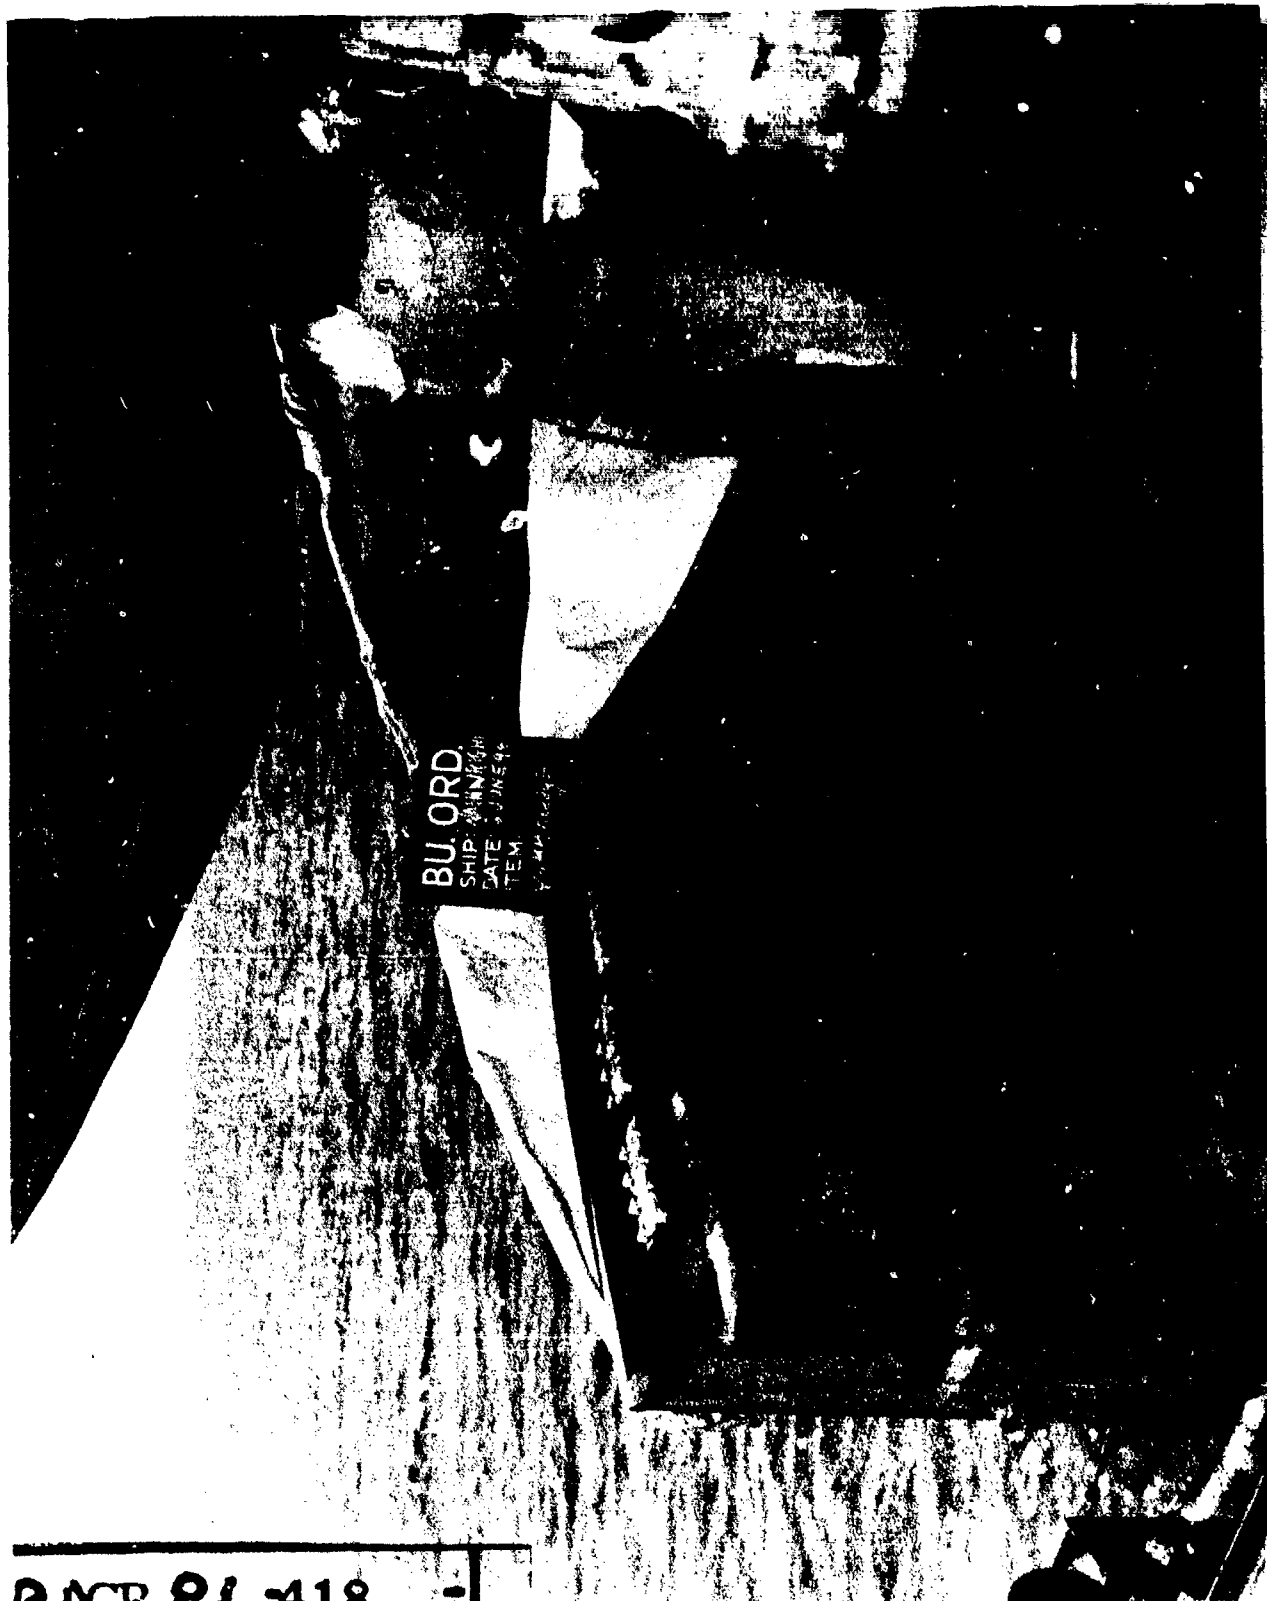
**RACR 81-418 -**

U.S.S. WAINWRIGHT (DD-419) - before Able  
Shows the exposed 40 MM Ammunition in the  
bulwark shields.  
Photo. No. RA-CR-81-418-6.

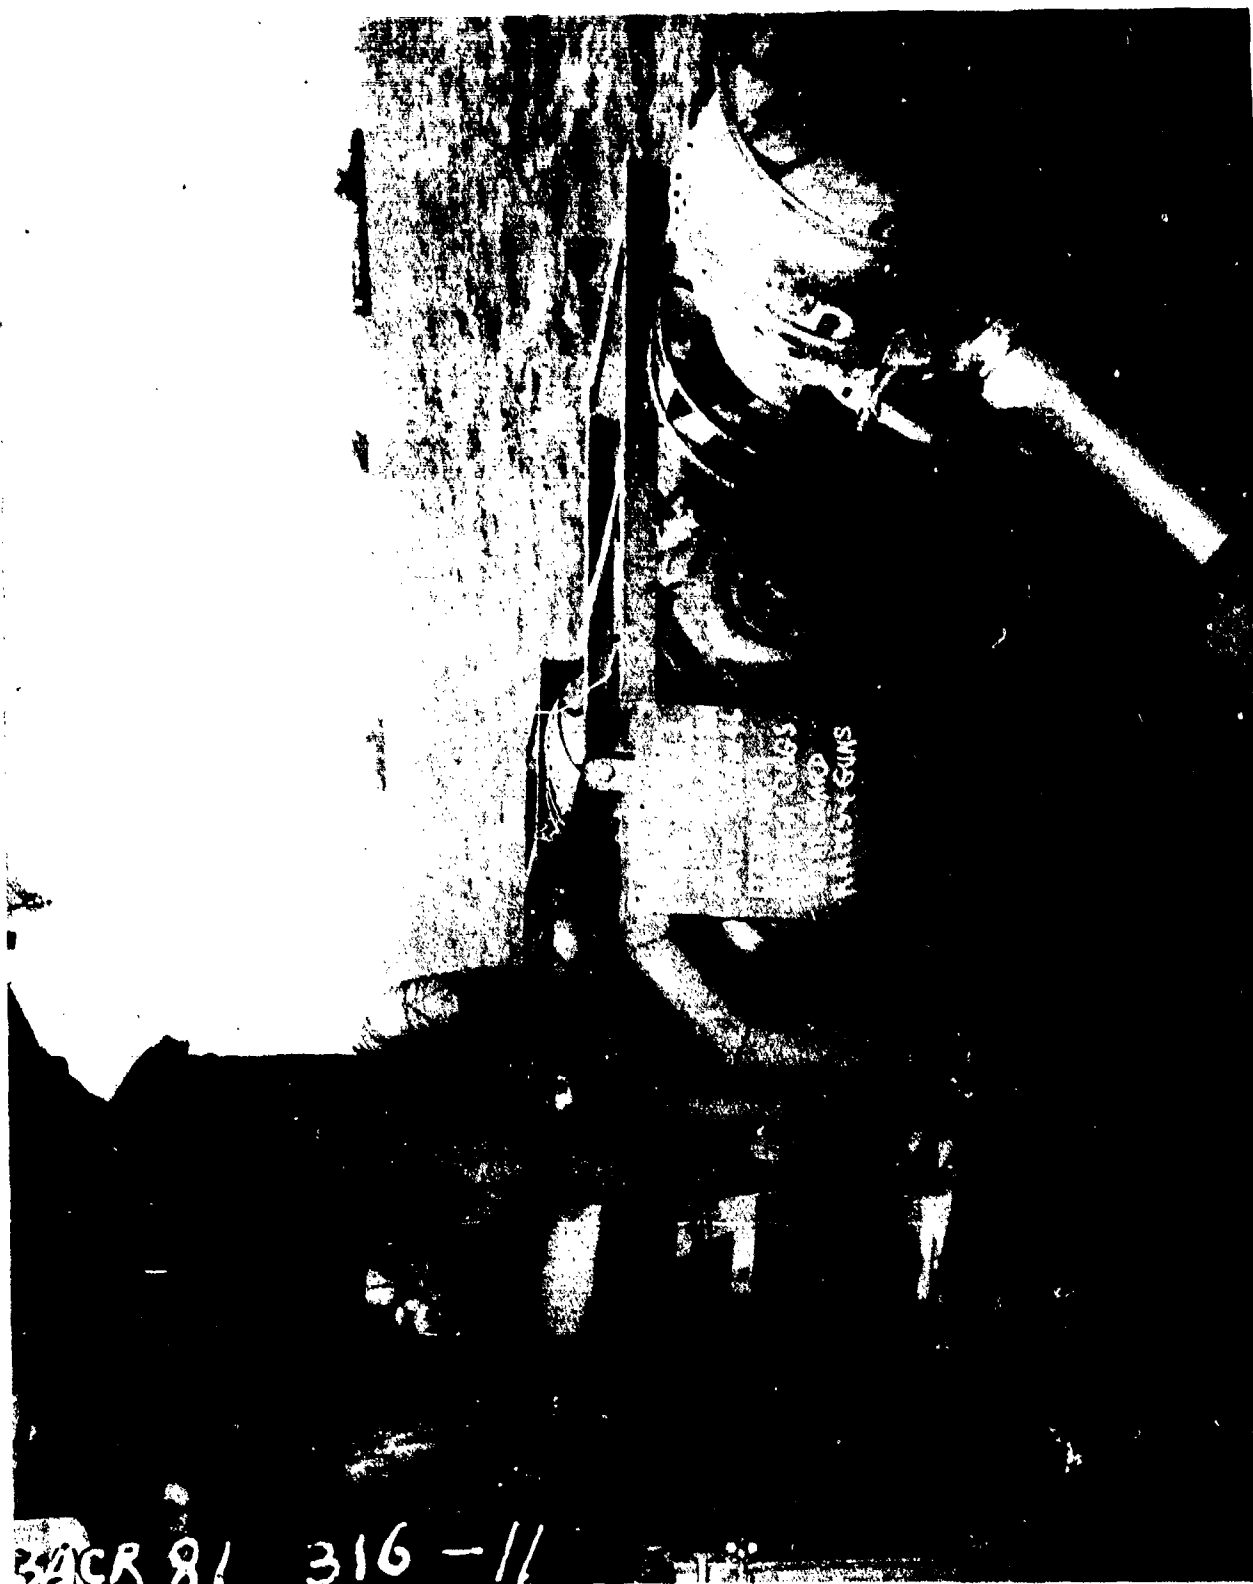
U.S.S. LAMSON (DD-367) - Before Able  
Shows the Depth Charges, Mk. 9 in position prior  
to Test "A".  
Photo. No. BA-CR-81-316-11.

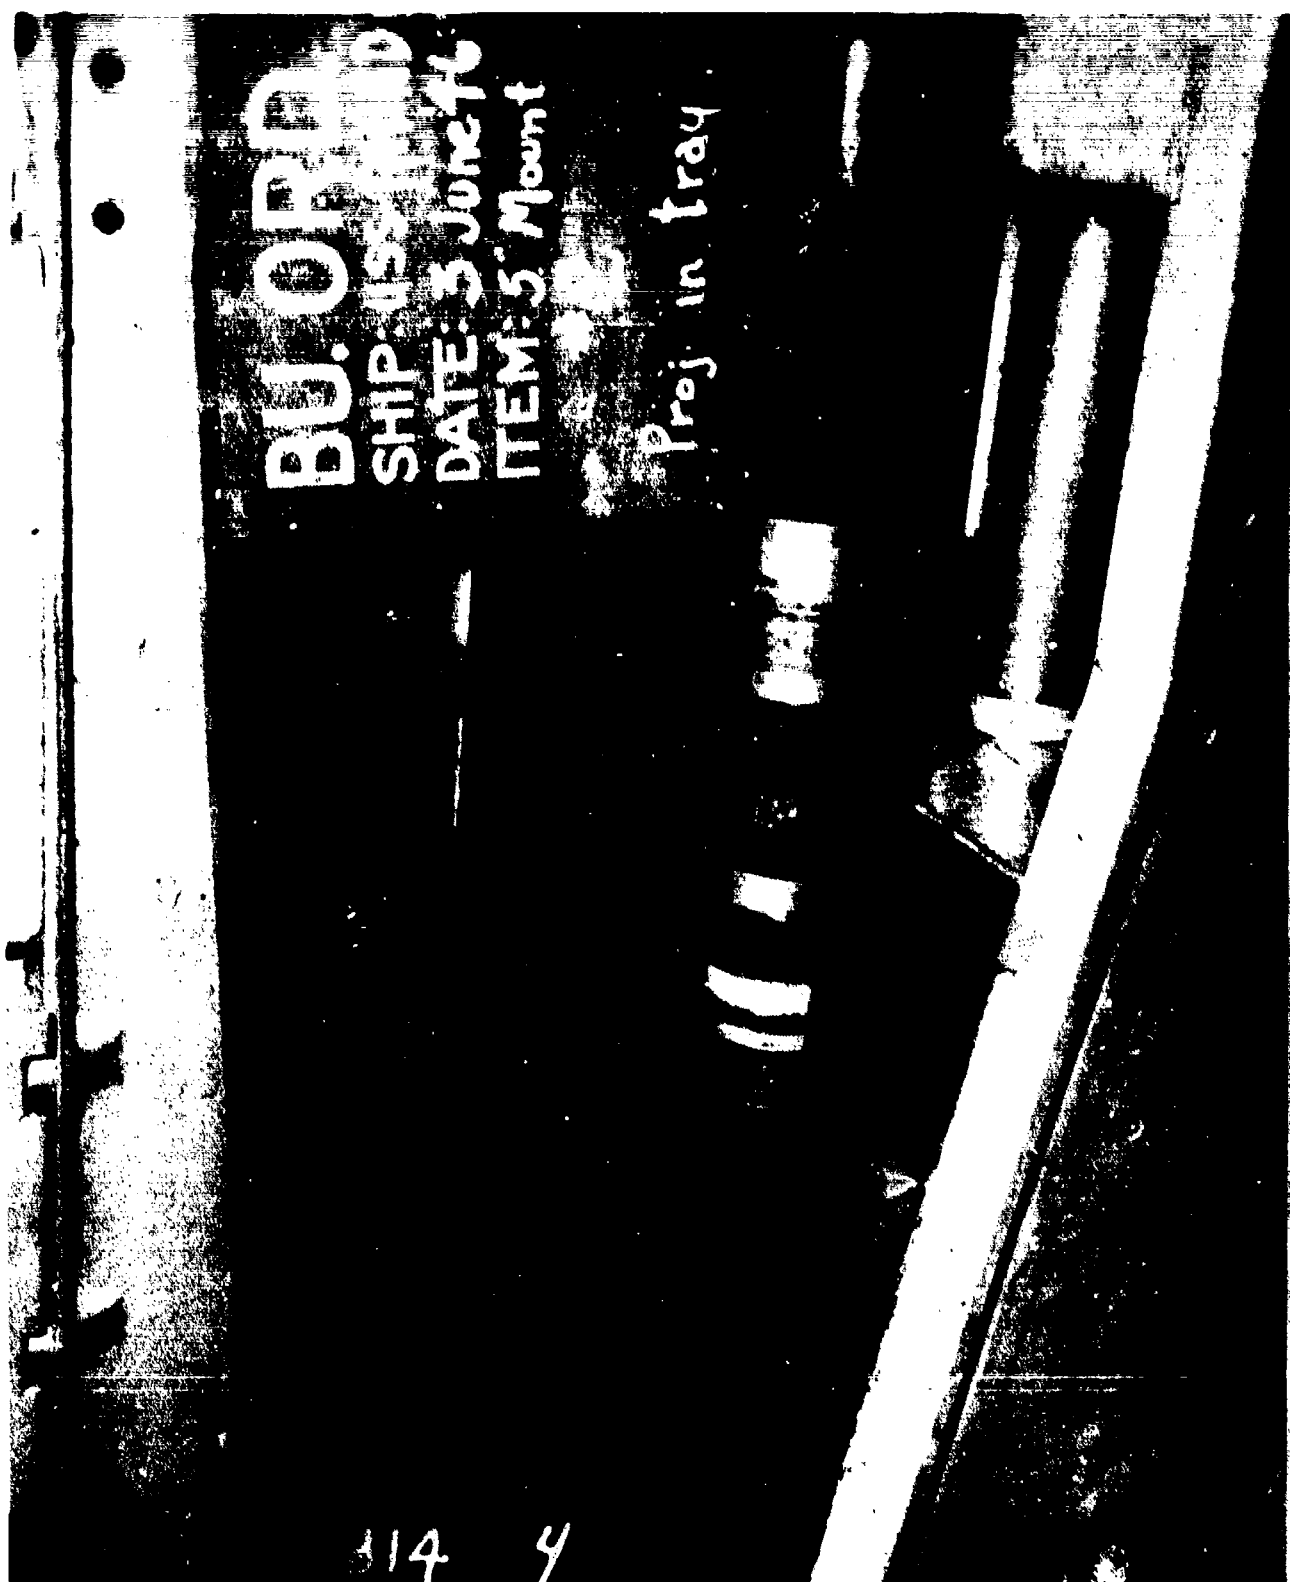
U.S.S. RHIND (DD-404) - Before Able  
Shows the (L&P) Special Test 5"/38  
Projectile in position on the Gun Tray.  
Photo. No. BA-CK-81-314-4.

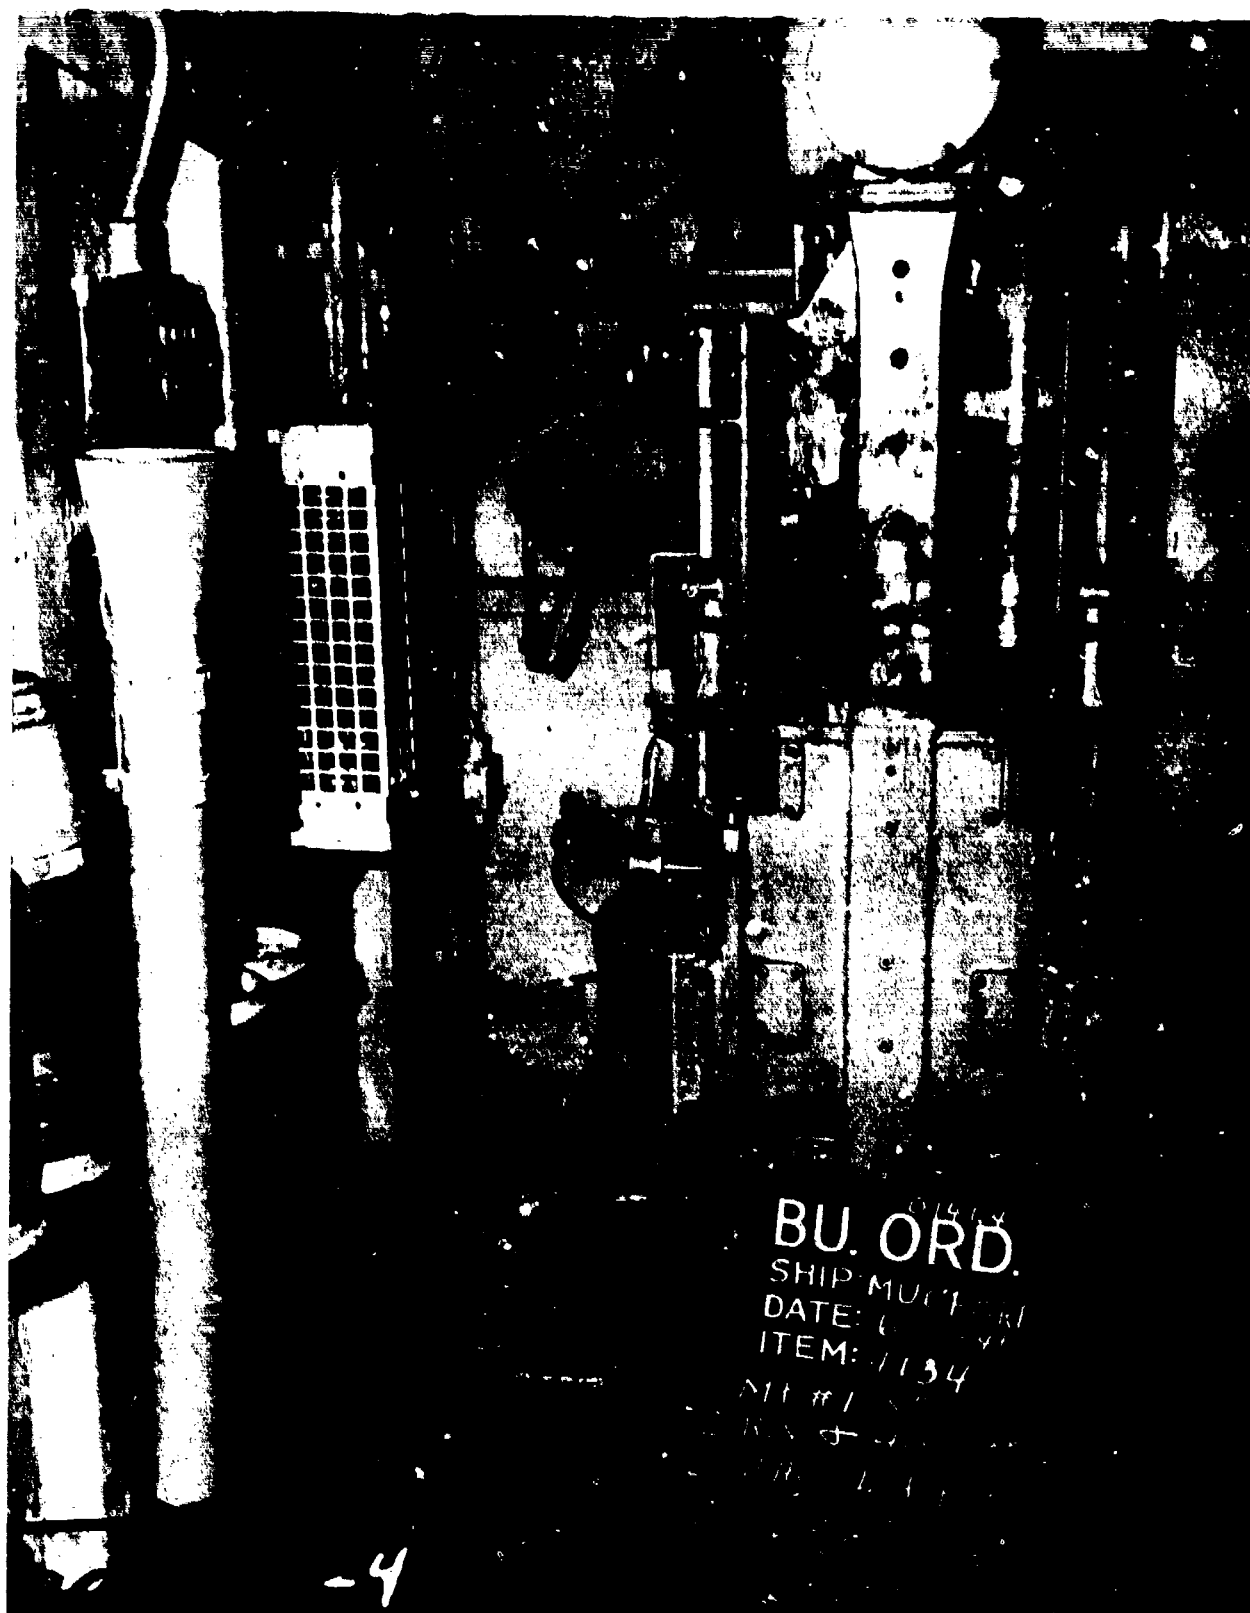
U.S.S. MUGFORD (DD-389) - Before Able  
Shows the (L & P) Special Test Ammunition in  
position in the Hoist and Ready Service Stowage.  
Photo. No. RA-CR-92-413-4.

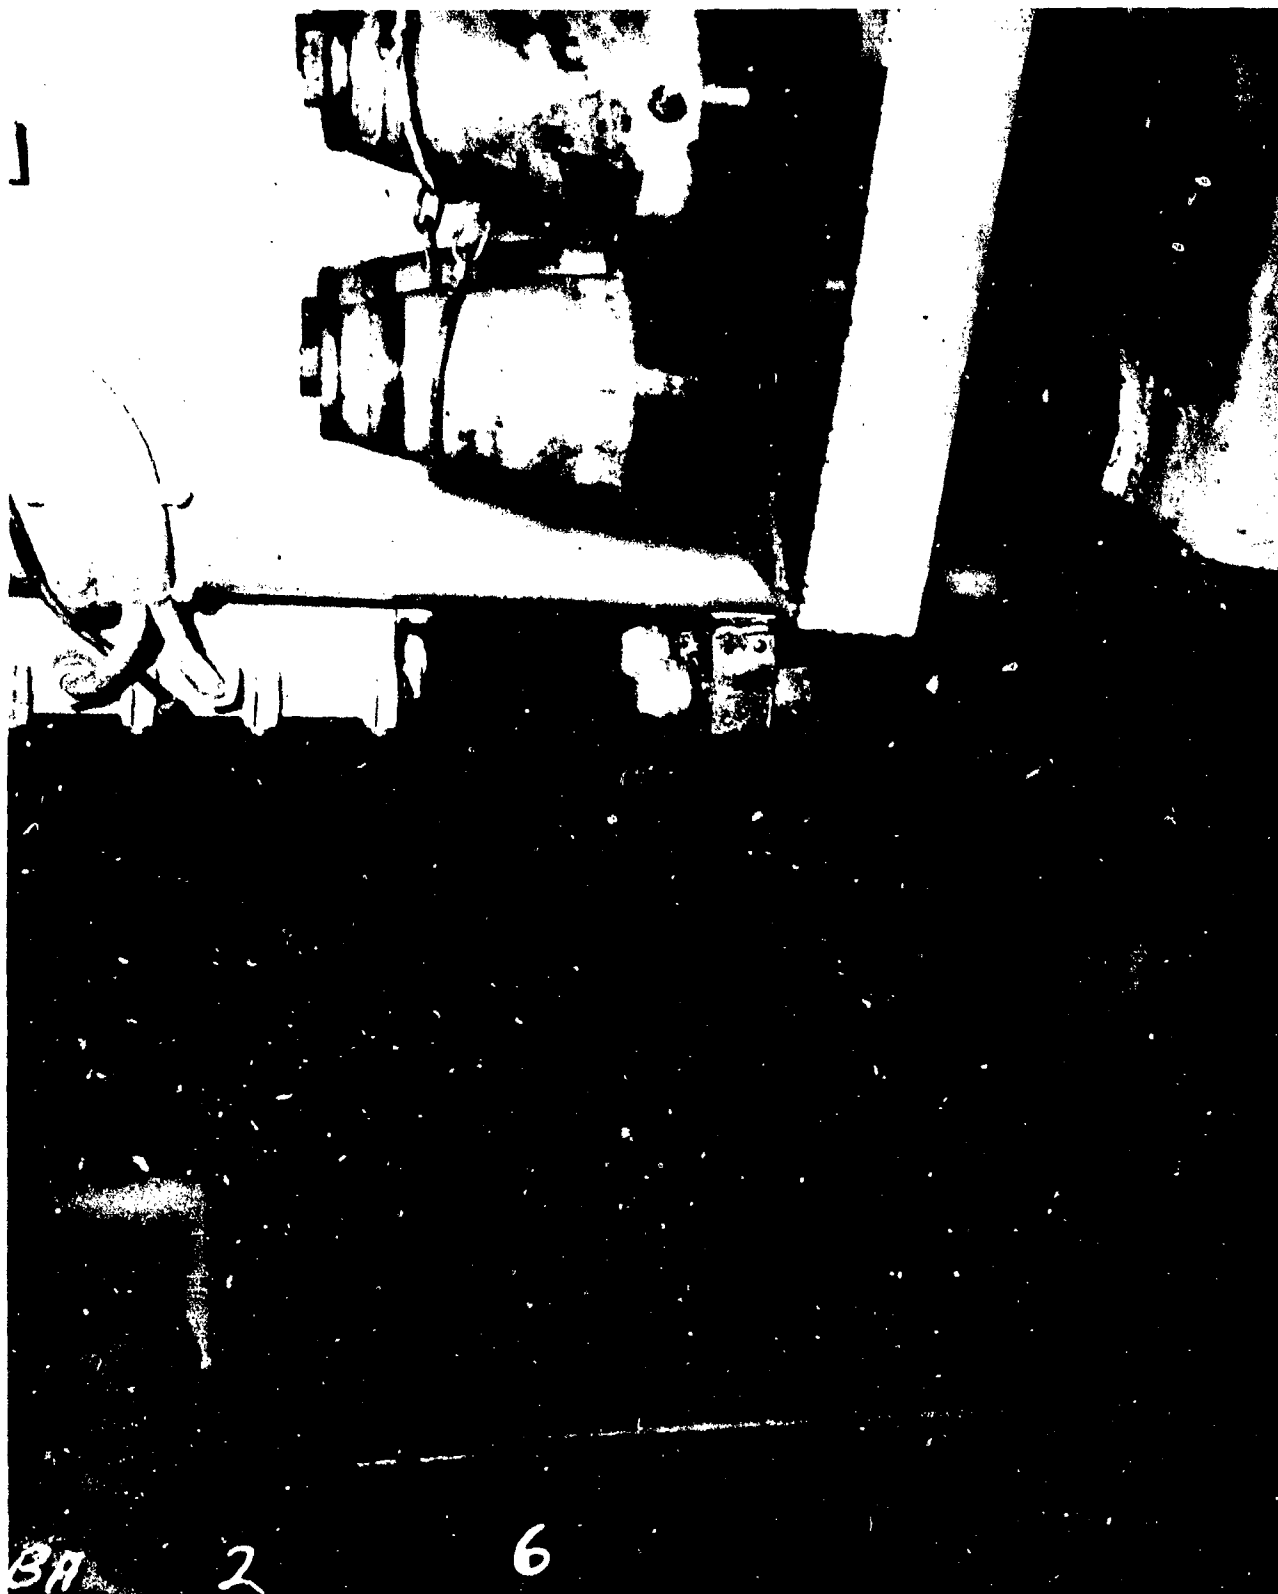
U.S.S. MUGFORD (DD-389) - Before Able  
Shows the 5"/38 AAC, loaded and plugged projectiles in  
the Upper Handling Room of Mount 5, prior to Test "A".  
Photo. No. BA-CR-92-413-6.
